# EnviroScope® & Investigation Report

Written by Jeff Charlton  
Qualified Member

## Summary of findings and taken from pages from Page 1 to p47

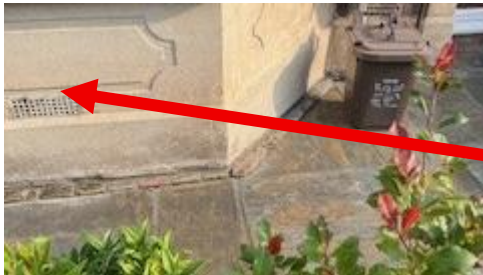
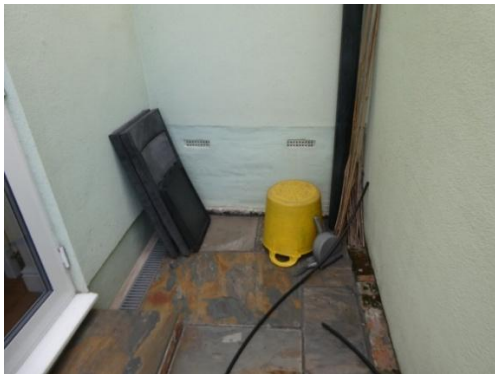
I am concerned about front-to-back subfloor ventilation, and this should be

investigated. This may be especially relevant regarding the damp front lounge floor. The air brick in the front is blocked and inadequate, with non-visible to the rear

The external back walls have been painted (sealed), which may prevent the natural evaporation of moisture and result in rising damp.

- The front lounge floor has ongoing water damage, which I believe is caused by poor subfloor ventilation.
- The subfloor ventilation must be improved, possibly simply changing to periscope vents

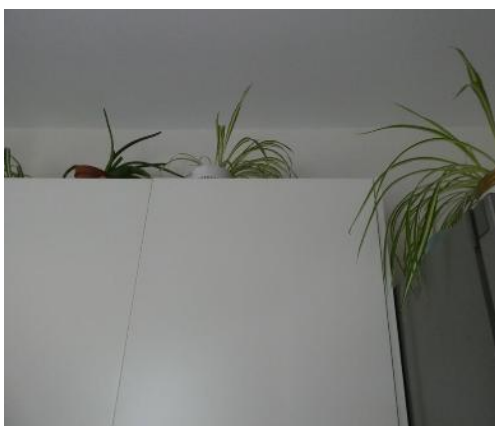
### **Extensive plant life**

There is a significant risk of topsoil mould from potted plant life. These should be removed.

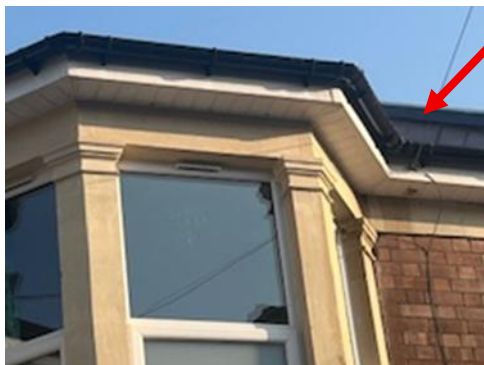
## Roof Ventilation

A roofing surveyor should inspect the new roof for design and construction because it appears there is inadequate ventilation

- Historic water damage must be intrusively investigated and perhaps with critical barriers to control any release of spores.
- Because the attic has developed into a roof loft space, I suggest a chartered surveyor or a roofing expert provide guidance regarding roof design, insulation, and ventilation.

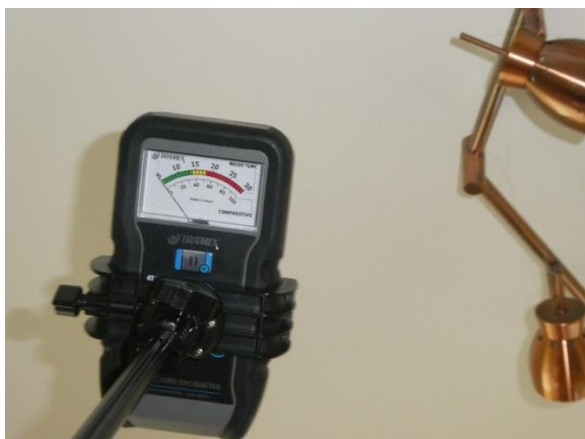
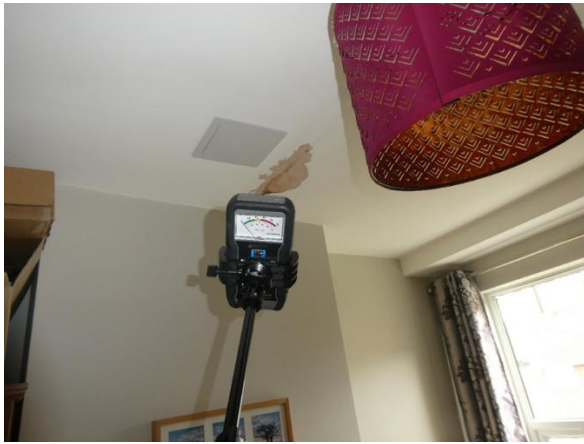
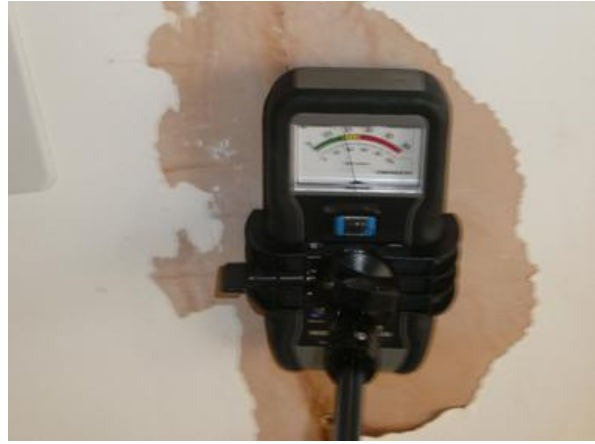
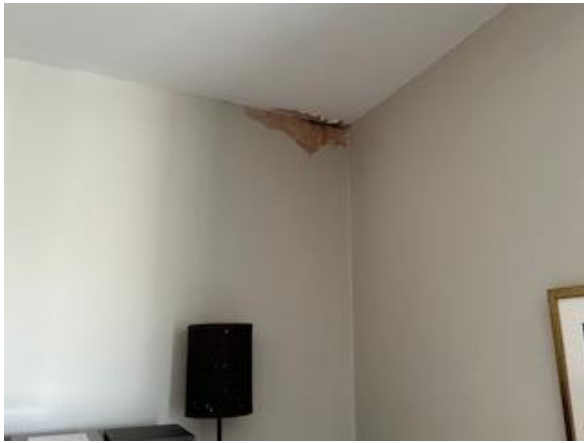
## Moisture Survey

All historic leaks in all ceilings have been allowed to dry naturally, and these are a major risk factor regarding mould exposure from the cavity reservoir. While some areas are dry, some are elevated, and water-damaged areas should **be intrusively investigated** to remove mould and decontaminate/dry them. Dead desiccated mould transforms into microparticles and can act like a gas, moving through plasterboard and via cracks. It is normally expected through whole-house ventilation.

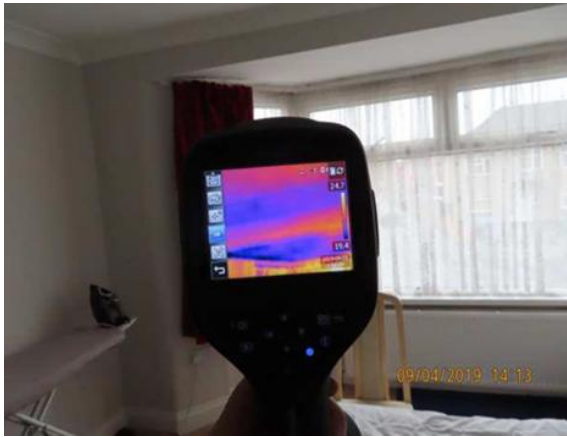
**Thermal bridging risk from construction**

Residual moisture from a leak two years ago

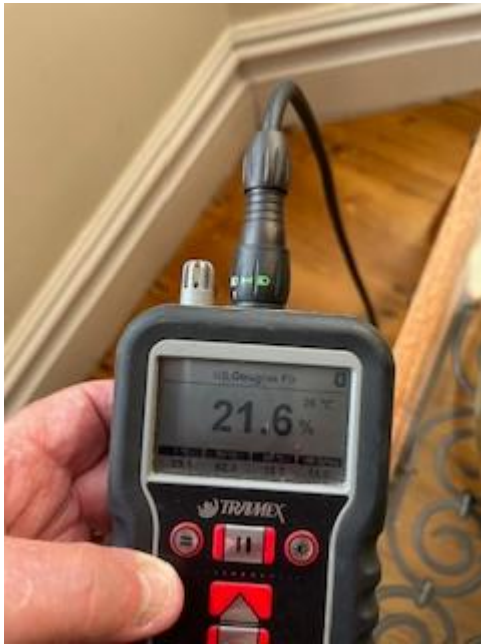
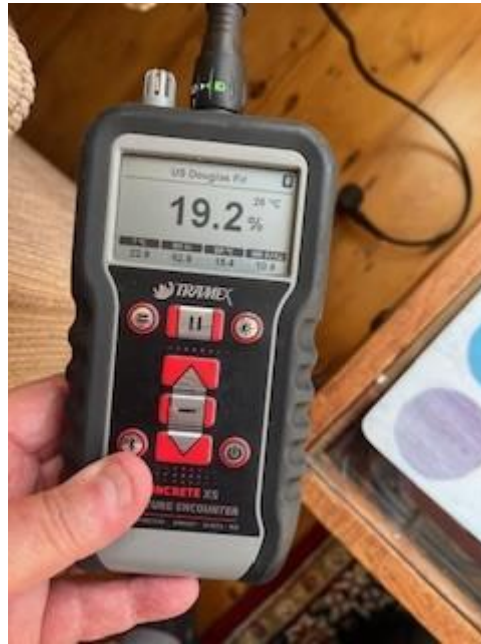
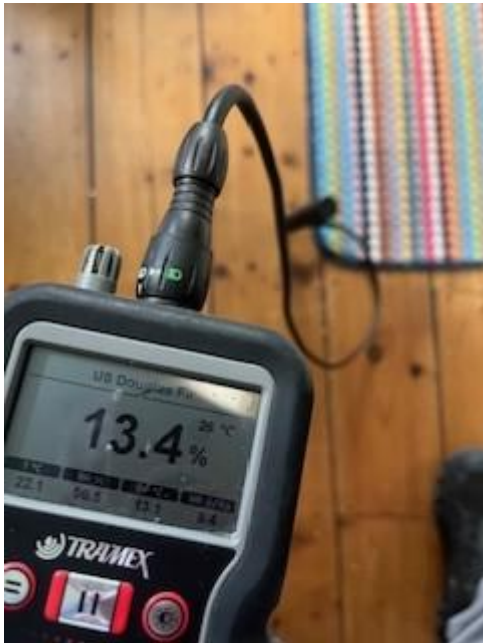
Front Lounge

Reached the trigger point for wet or dry rot

The front lounge floor is wet and approaching a level of wet rot decay and mould. This can be remedied by improving subfloor ventilation

The moisture levels vary across the floor, and this may or may not reflect the effectiveness of localised sub-floor ventilation. Mould can be expected to develop

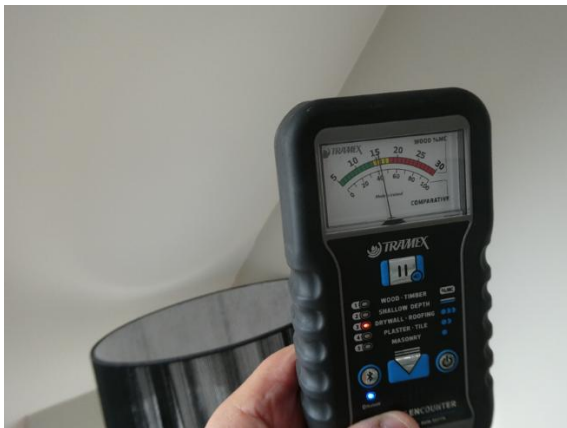
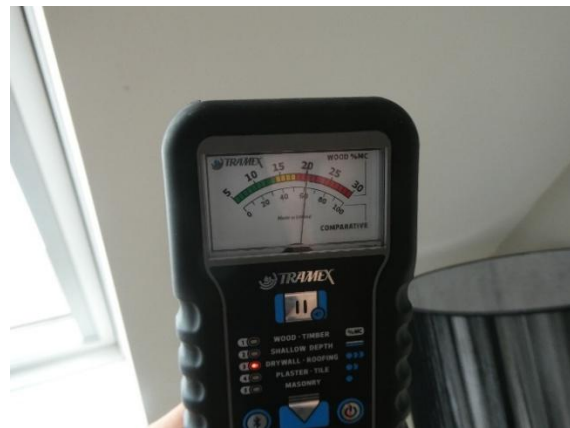
## Main Bedroom

The sloped ceiling has an elevated and differing moisture content. This may be due to poor insulation, dew point condensation, or leaks, which can only be identified by intrusive investigation.

The window reveals and the ceiling around it have elevated moisture content, indicating possible mould growth, condensation, leaks, or being left open during rain. Again, this must be investigated with an intrusive investigation.

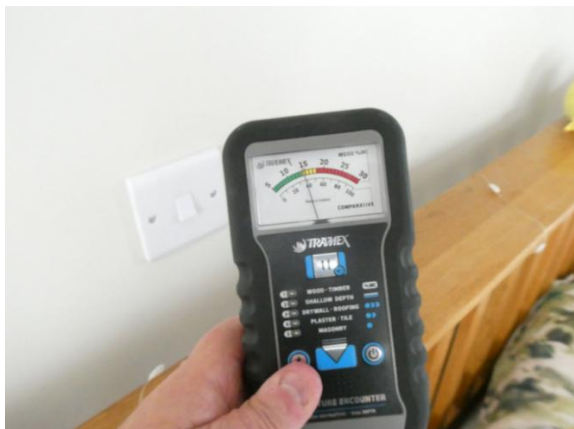
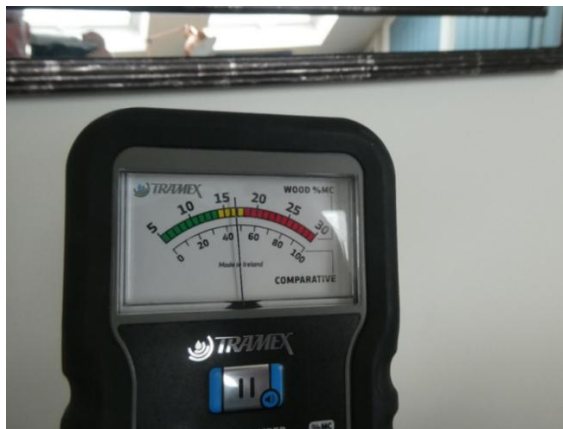
## Main bedroom Headboard Wall

Here we see minor but distinct differences in plasterboard moisture content. These are not major differences but may be linked to ongoing or historic issues

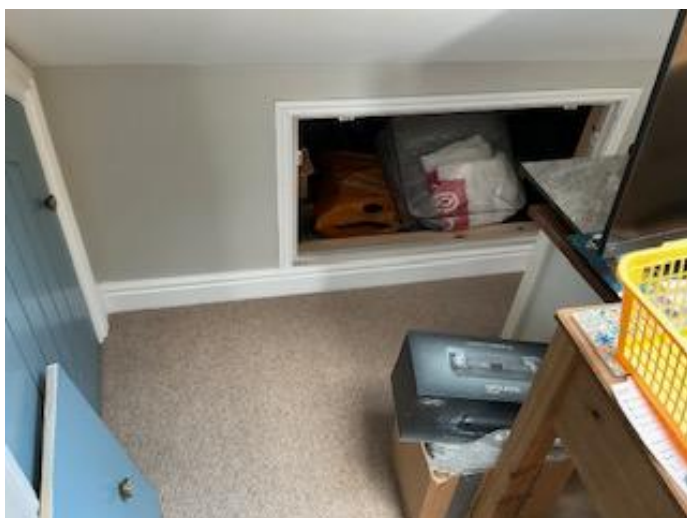
## Roof cupboard

The roof cupboards have elevated spore counts, which the roofing expert should assess as likely due to a lack of ventilation, dew-point condensation, or inadequate insulation.

Ensure the roof soffit vents are clear and the partition wall to the bedroom is well insulated; however, this may be due to soffit vents or poor local roof insulation. The roof survey will assess this.

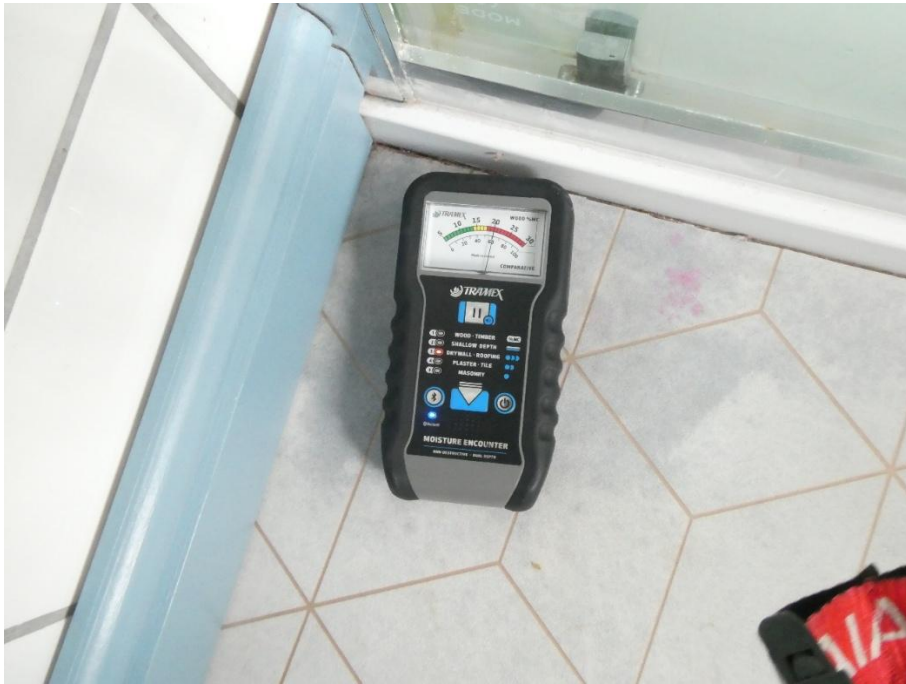
## Shower Leak

The vinyl floor shows discolouration around the suspect water leak area, which is also shown to be wet compared to adjacent areas.

Showing 22%

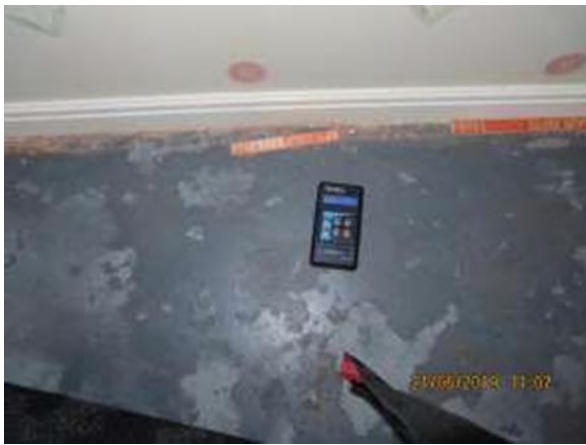
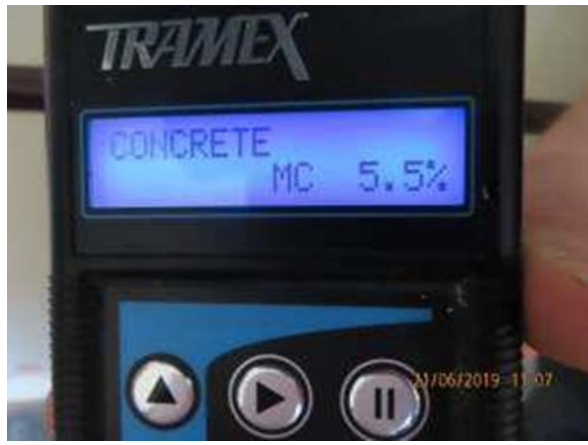
Concrete floor, wet and damp proof membrane, is suspected as faulty

Area	Type of test	Reading	Concern
Lounge	Calcium Carbide	5.5	Wet *
Kitchen	Sleeve	80%	Wet

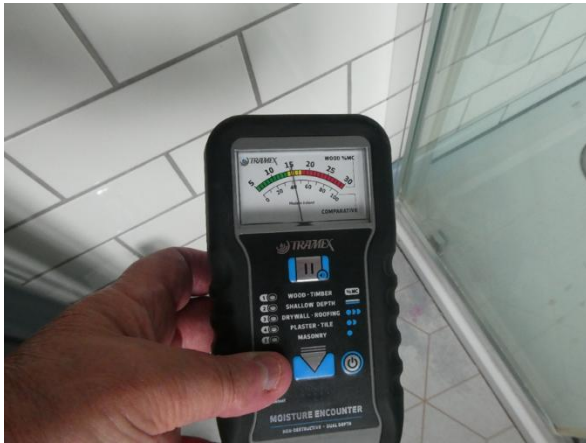
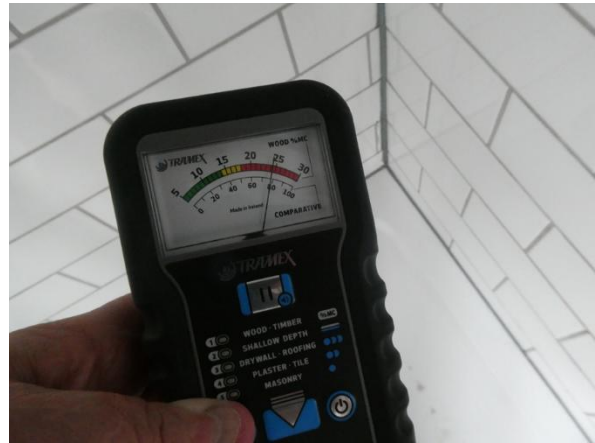
These two readings show the inside corner of the shower of the partitioned bedroom wall at 24% against 15% outside the shower cubicle, which corresponds with readings on the other side of the wall in the bedroom. There is a leak.

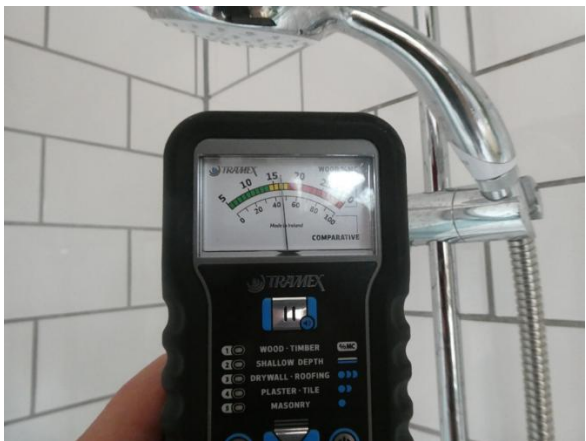
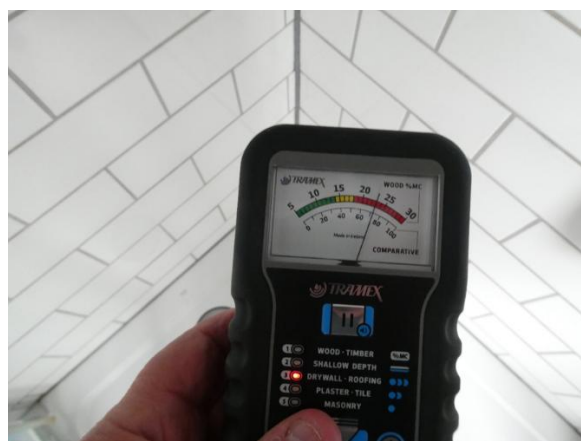
These photos show the moisture differences between the shower tray level and the shower head height. There is no doubt that the shower has a leak, and it has affected the two corner walls where it is fitted, the surrounding floor, and the adjacent main bedroom wall. I suspect it may have affected the ceiling directly below, too. I suggest opening the ceiling below for inspection and/or removing the shower tray and localised floor.

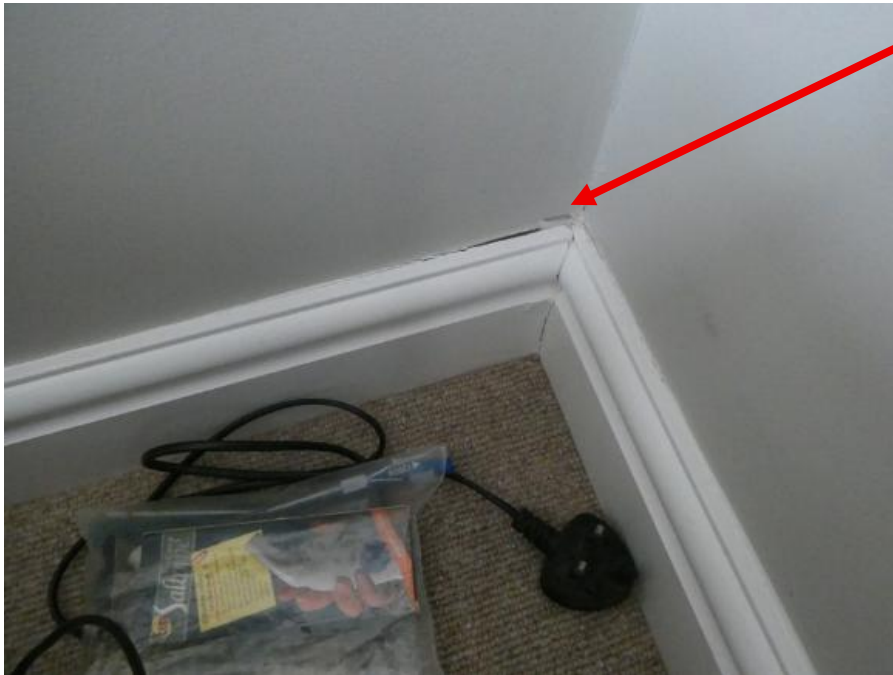
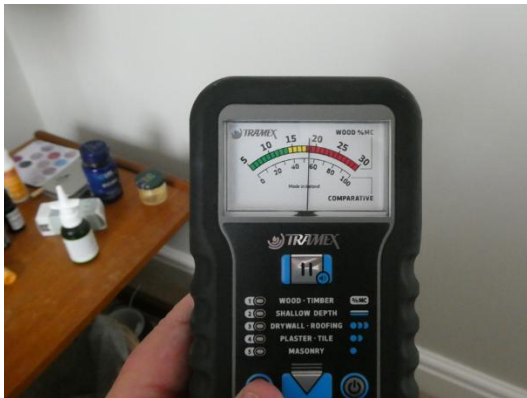
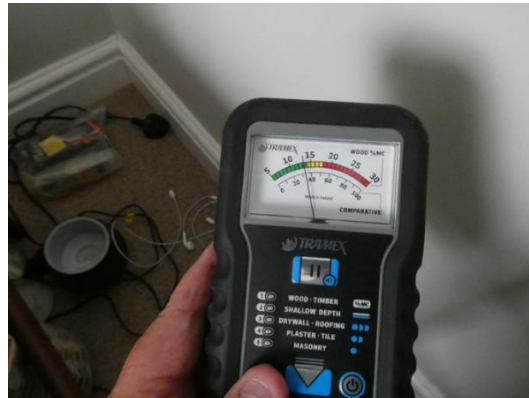
### The shower leak affected the Bedroom

The shower leak has, in my opinion, affected the adjacent bedroom wall. In the first photo, we see the typical swelling and shrinkage results of water damage (arrowed). The wall's moisture content also differs as it moves away from the corner. This corresponds to the moisture pattern in the adjacent shower room.

Although not classified as wet the areas are damp and have been affected by water damage and almost certainly mould growth within this cavity wall

The sauna is another major biological amplification source. The shower leak has caused a major mould risk in your bedroom and adjacent areas and must be remediated.

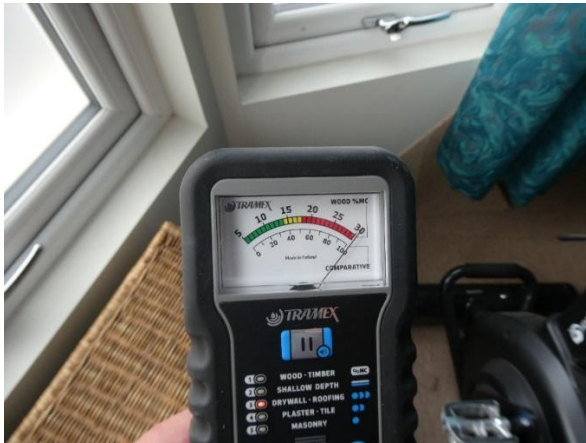
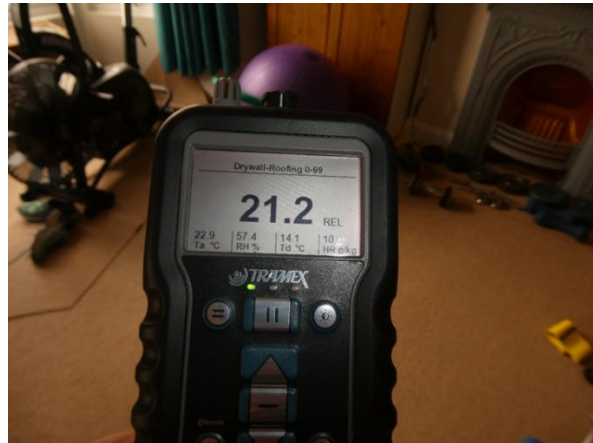
## Gymnasium

The bay window's impedance meter moisture content is a concern; however, the strength and absence of visible mould or staining lead me to believe the construction is metal foil-backed plasterboard or cement board, which would provide a false high reading. This should be addressed by an intrusive investigation

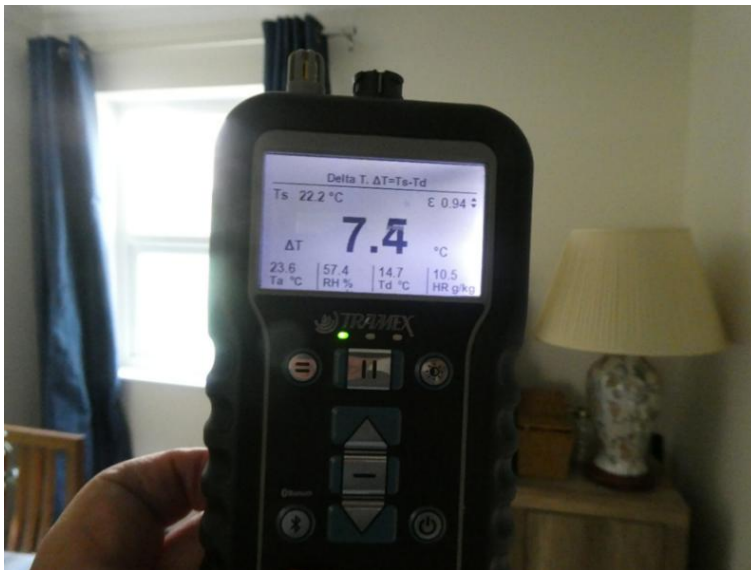
### Dewpoint Risk

The following photos show wall temperatures and dew point. All are above the Dew Point on the day, and surface condensation and mould are unlikely (except for the shower, which may see moisture in use but not through the dew point).
