Silver mould and water damage risk assessment

The objective of this survey is to identify areas within the property which may or may not be responsible for the building-related illness. Its focus is on water damage in its various forms. This may include historical events in which dry contamination reservoirs may still be present.

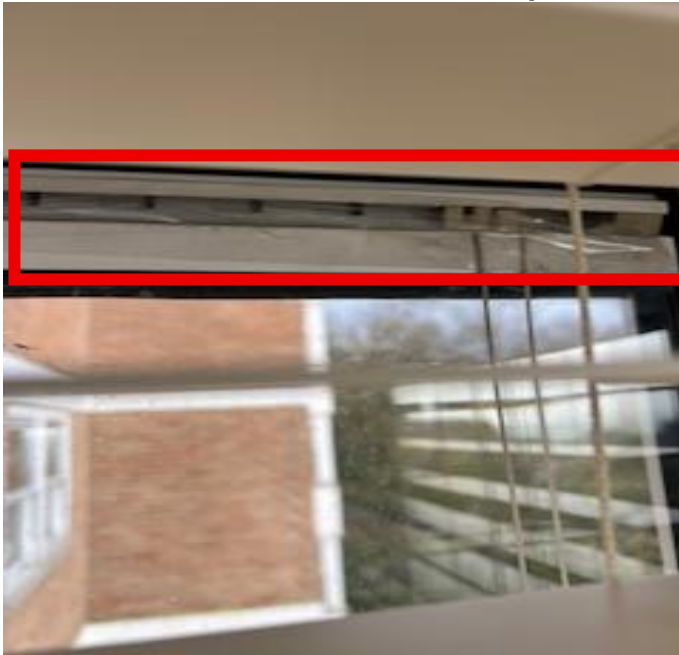
3.1. Window vents – Yes, noted sellotaped and closed in lounge, below

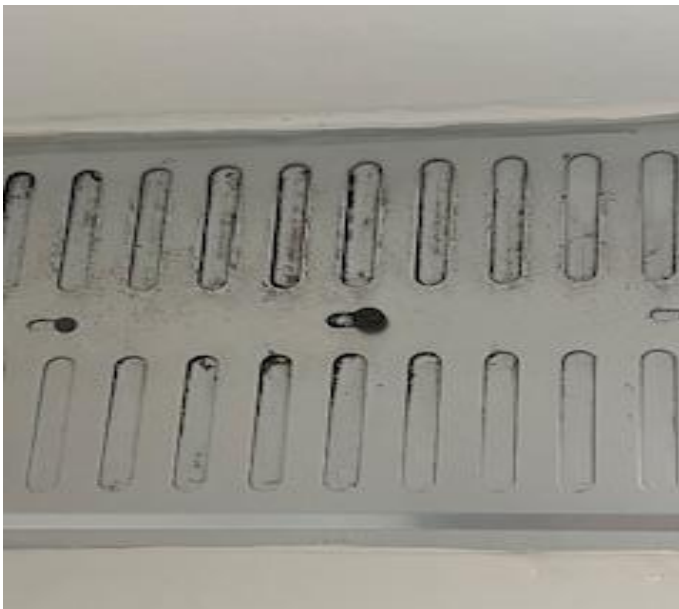
The apartment toilet has a communal vent shared by more than 40 apartments, I believe, which is extracted to the roof of the building. Not identified as working during the visit

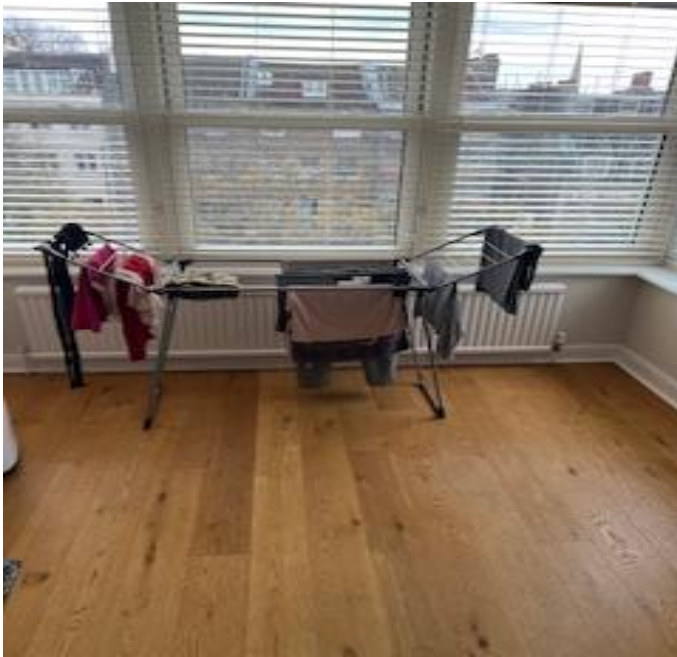
Washing being dried in the lounge will add to the moisture load and increase mould risk

The client advised that a dehumidifier is used to dry the clothes

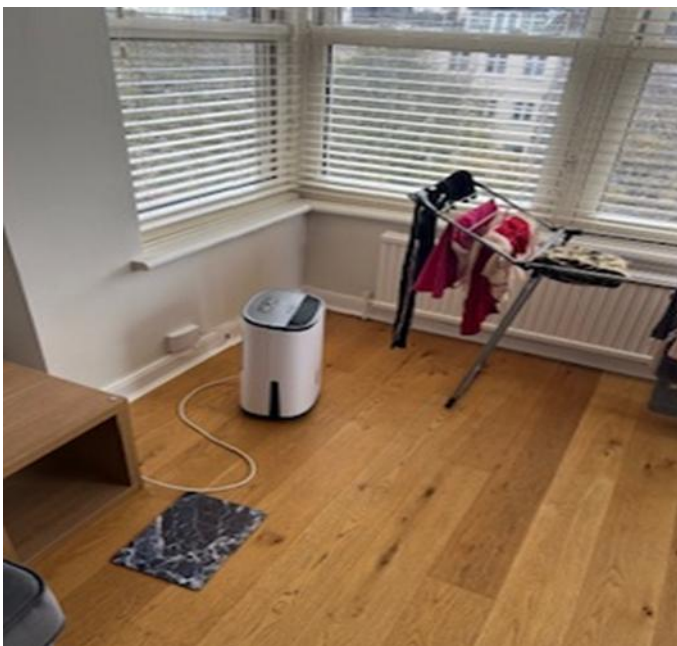
The dehumidifier is outlined.

These types can be a major source of toxic moulds and should not be used when a health issue exists

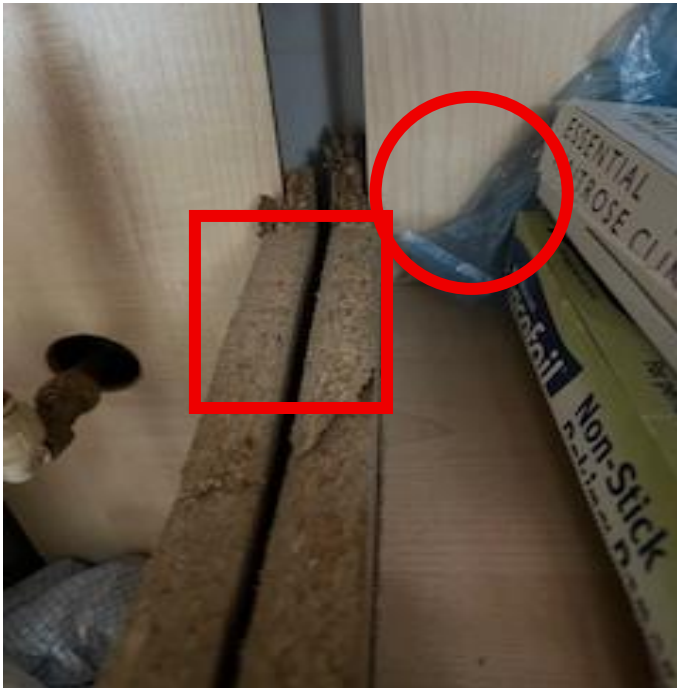
Swelling and cut out pieces may indicate a historic water damage event and likely hidden mould

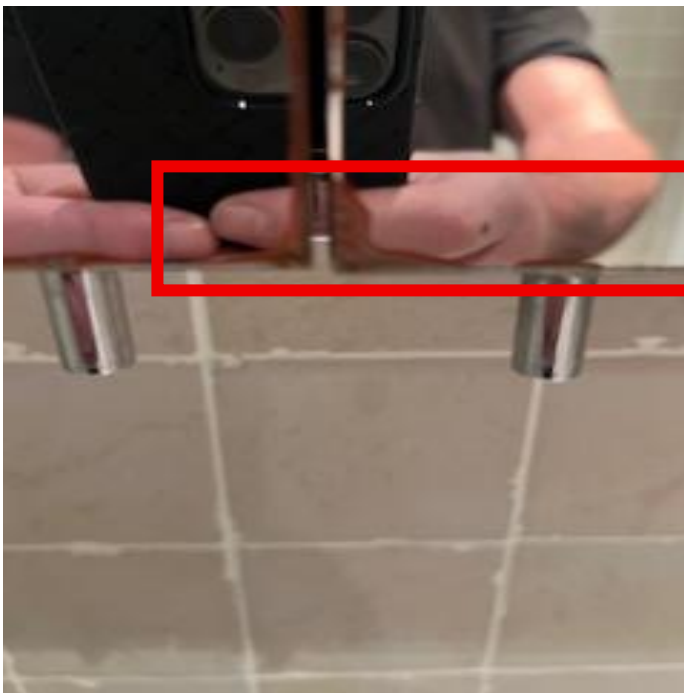
Shower mirror showing signs of moisture damage and condensate may be present behind the mirror

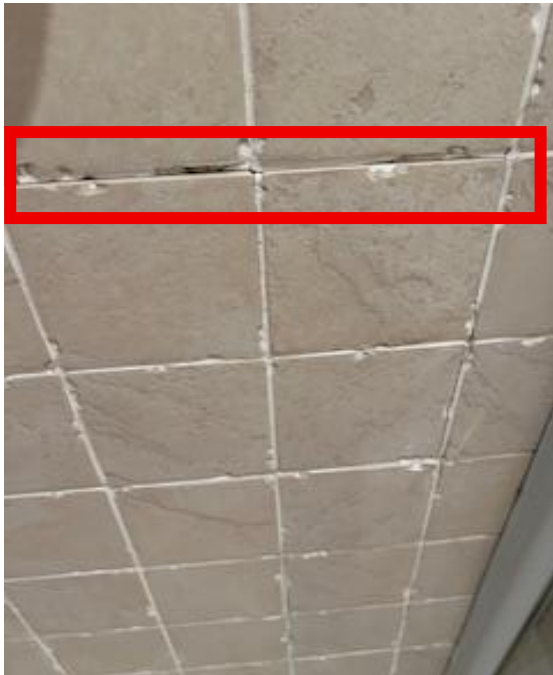
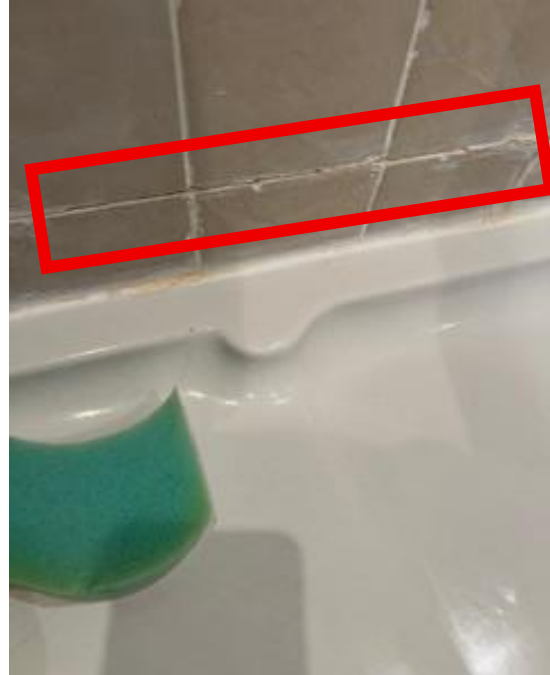
Shower room above, tiles in places need regrouting. These are set onto a plasterboard wall, and the reverse side is damp. Re grout and intrusive investigation

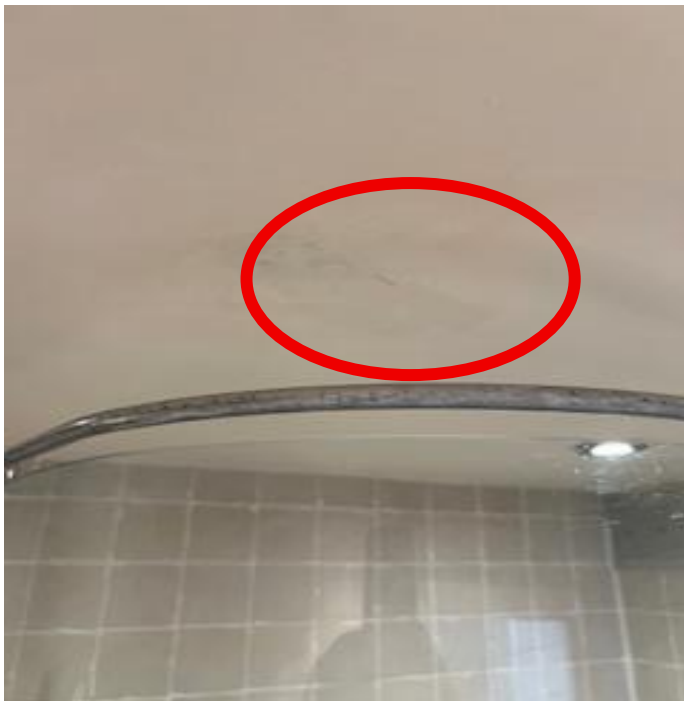
Shower room above, slight staining on a plasterboard ceiling, noted the flat has only two plasterboard ceilings, a shower room and a toilet, the rest is concrete. This is a major concern

Shower room above, plasterboard ceiling highlighted under the stain section, tested with a pin probe with an acceptable moisture reading 07.8%, but may be a hidden mould reservoir due to telltale staining.

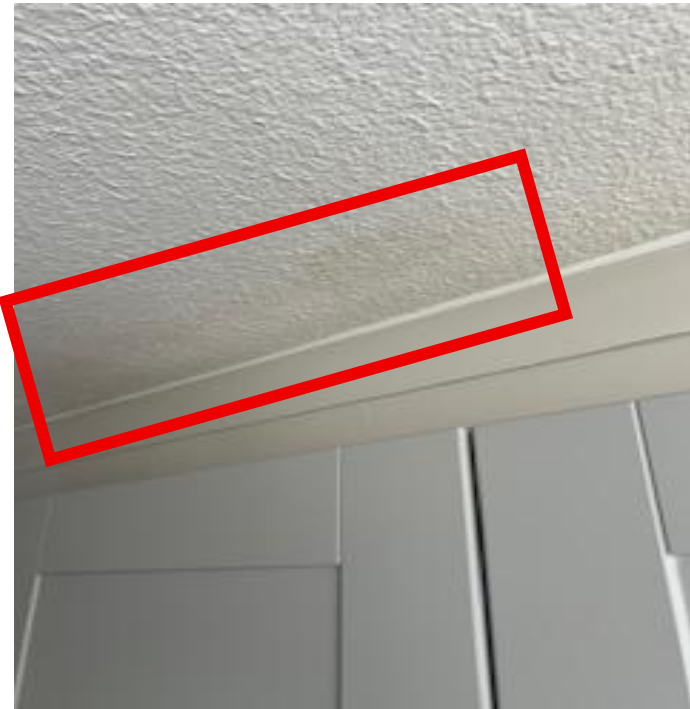
The kitchen's concrete ceiling above, with yellow stains randomly around it, I believe to be either poor decorating or grease stains from cooking.

Kitchen ceiling above, concrete ceiling highlighted in the stain section, with a low moisture reading of 19, which was consistent throughout the kitchen ceiling.

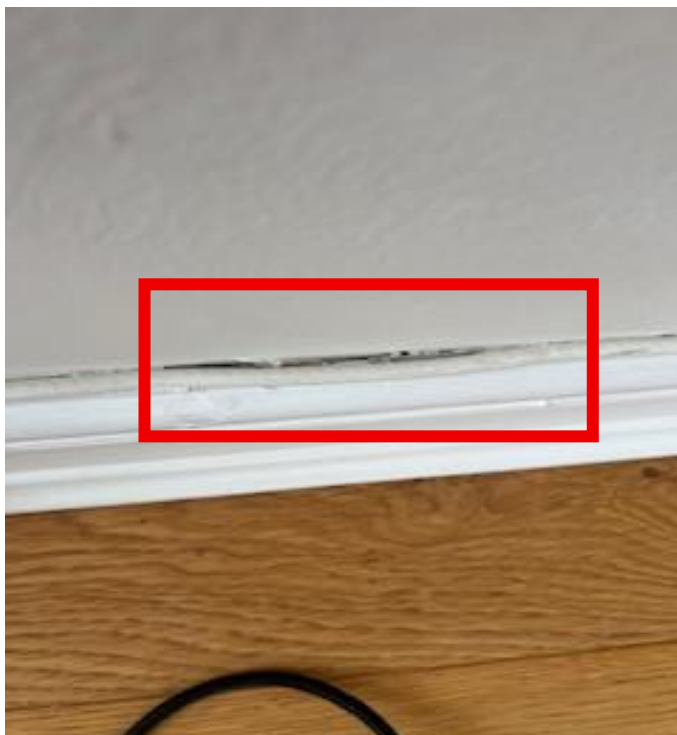
Lounge bay window above, skirting with slight swelling indicating historic water damage. With wood chip wallpaper, this is a major concern and risk factor of mould growth. Although now dry, there remains a risk of toxic mould behind the wallpaper.

Lounge skirting above, highlighted in the swelling section, directly under the area in the previous picture, bay window wall, tested with a pin probe with a moisture measurement of 13.5% and a comparable reading of 8.2%. This does indicate historic water damage, and the skirting should be investigated. I advise removing the wallpaper.

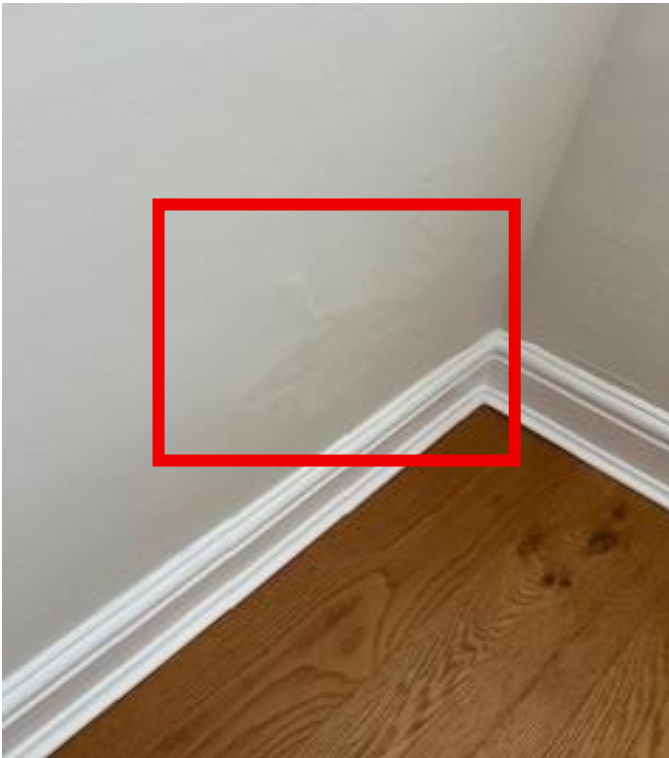
The lounge wall has undergone isolated redecoration before the owner's purchase. This may be camouflaged historic water damage.

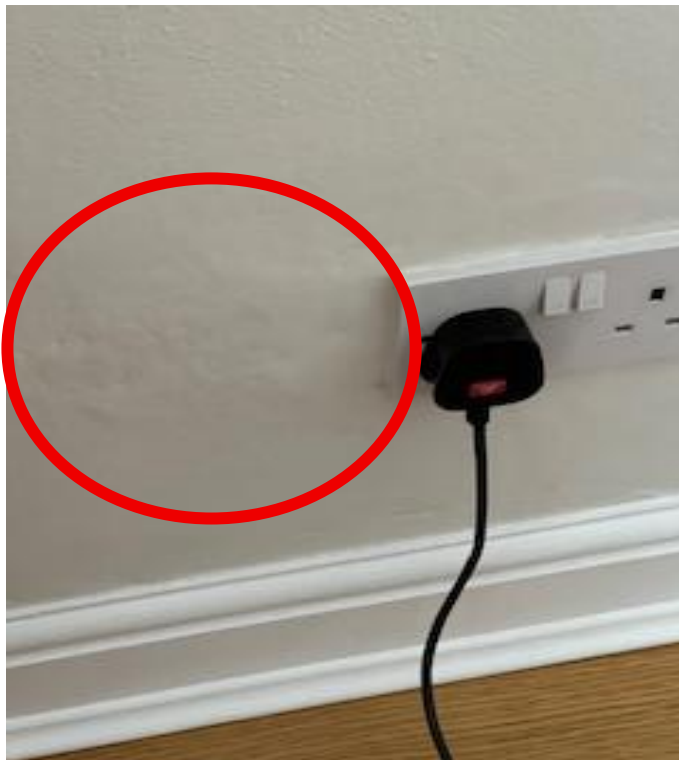
Lounge above, masonry wall with signs of pre-isolated repair, before the client redecorated,

Lounge above, highlighted in the isolated redecoration section, I believe this area had previously been repaired before the client redecorated. Now dry.

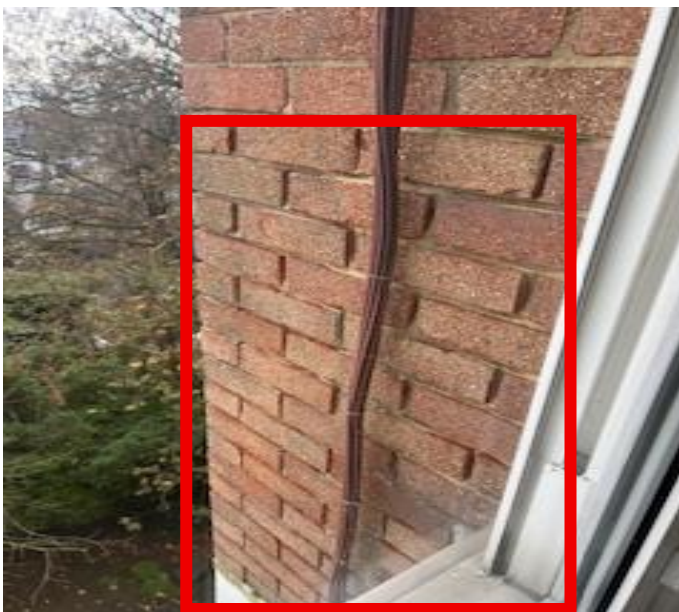
Also, the external part of the lounge masonry wall, where the client advised of damp marks, the brickwork joints have been raked out, but were not reinstated.

View from bay window, also faces the sea, pointing has been raked out, above

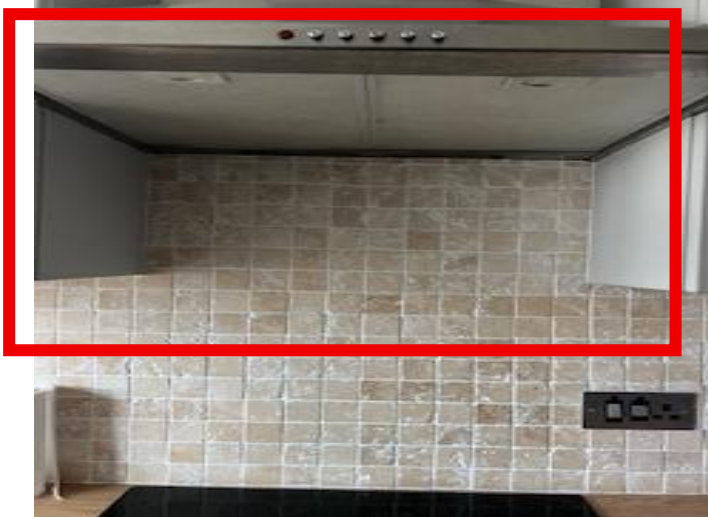
Kitchen above, self-circulating extractor hood,

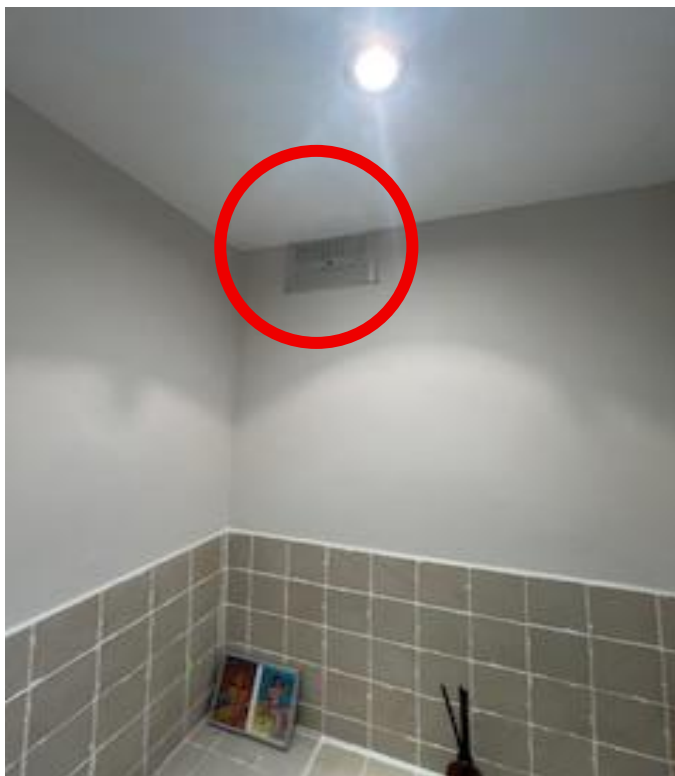
Toilet above, communal extract fan, noted black residue on the surface,

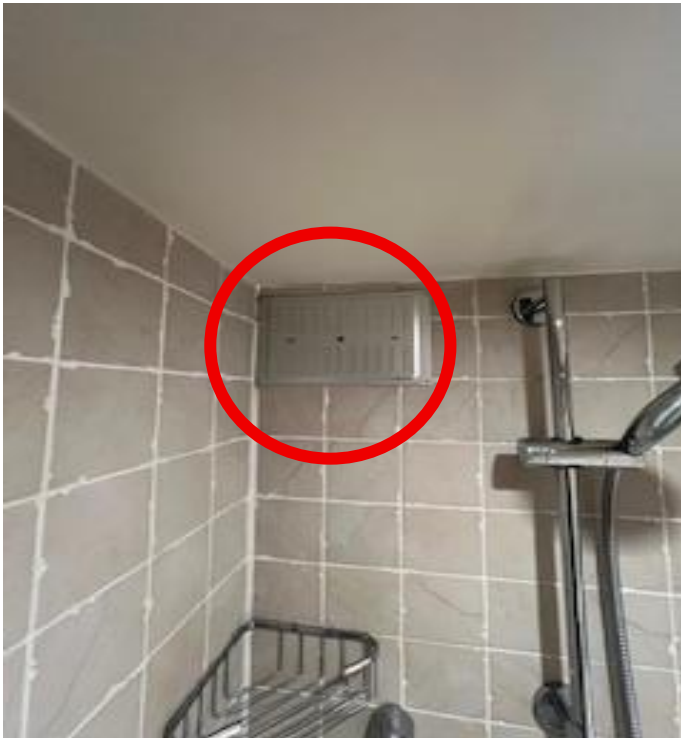
Shower room above, communal extract fan,

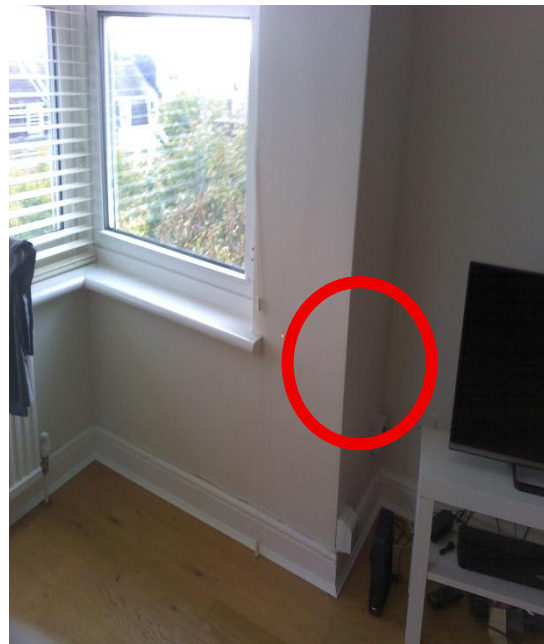
Lounge above, bay window, moisture reading of 26 and a comparable reading of 03 on a masonry wall. Considered damp, possibly from the dew point of penetrating damp. Dew Point found to be 4 degrees above the target risk level.

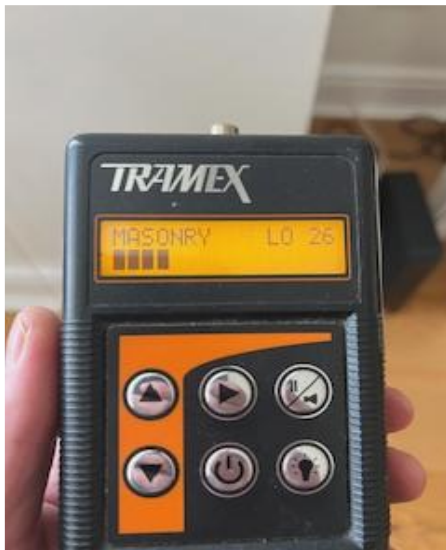
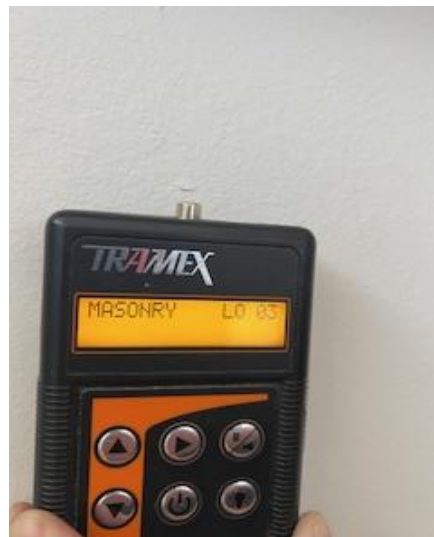
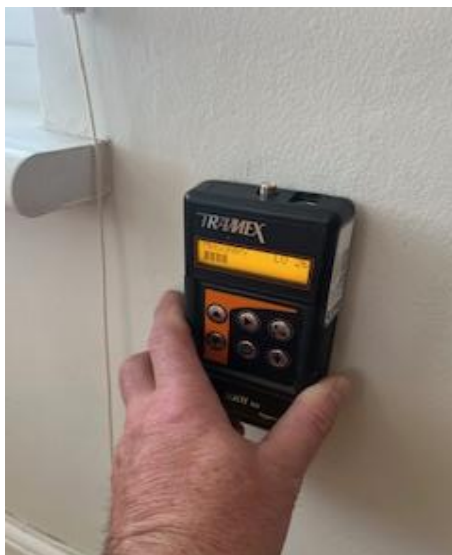
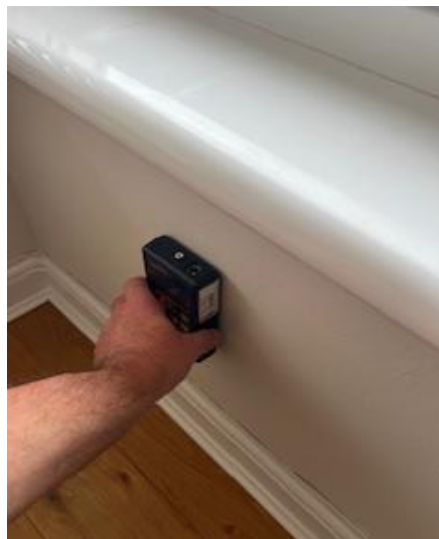
Lounge above, the client advised that this wall had signs of damp when they first moved in. The client had a mould survey carried out, which listed this area as dry. Tested area with a low 26 but a comparable reading of low 03, also noted the comparable reading was relatively consistent throughout the lounge walls. This may indicate historic water damage and hidden mould reservoirs.

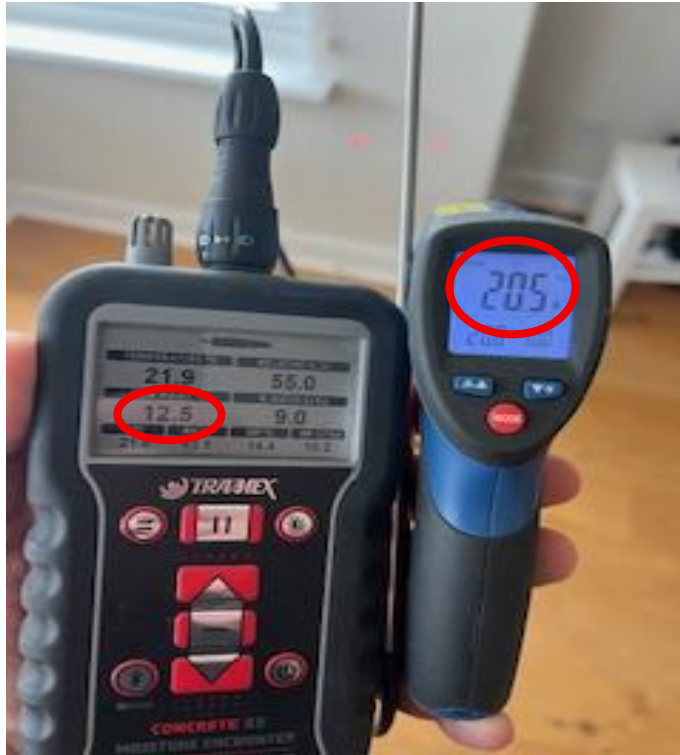
Typical findings: all walls well above dewpoint
