## Case 1

### Environmental Microbiology Summary: Bacterial and Toxin-Producing Contaminants

**Inspection Reference:** BF-ENV-25-08-JCS

**Prepared by:** Jeff Charlton – Building Forensics

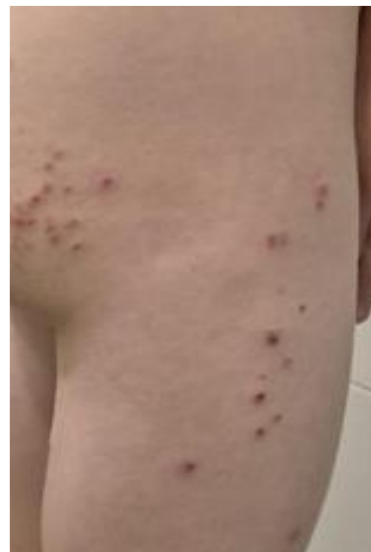
**Several bacteria and mould species have been identified which are associated with both neurological respiratory issues and chronic fatigue**

Occupants currently report dermal irritants or opportunistic pathogens capable of producing pustular skin lesions, as seen in the photograph.

5. **Medical liaison:** If lesions persist, provide this report to the GP or dermatologist for correlation with culture or swab results.
6. **I recommend our safe Hypochlorous Acid Micro dry fog as an intermediate resolution during detailed cleaning and decontamination.**
